## **Building Condition Survey (Example)**

## **BUILDING CONDITION REPORT**

- 1.14 Description –** The property comprises a four bedroom two storey detached dwelling of 1830 Georgian architecture. External walls are of traditional brickwork, and the roof is pitched and slated. The property is set within extensive grounds, which contain independent buildings of traditional and sectional construction. The main property frontage faces East.

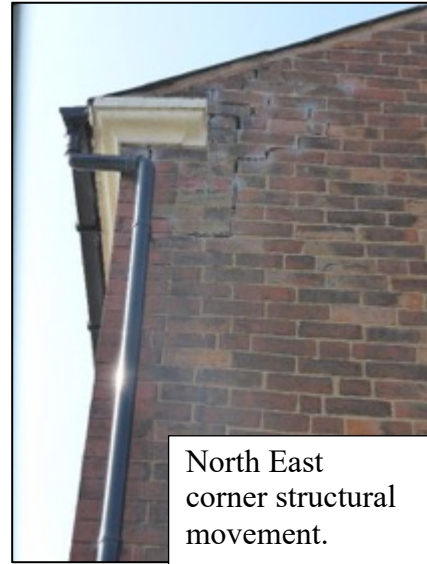
North East corner structural movement.

**Action** – Re-align and repoint brickwork arch above window to room FF09 £  
 Georgian lintel to window of GF02 - Remove previous repair pointing to, re-align rubbed brickwork arch keystones, and repoint in lime putty mortar. £  
 North East corner – Install stainless steel resin bonded twist ties to improve structural stability of corner. £

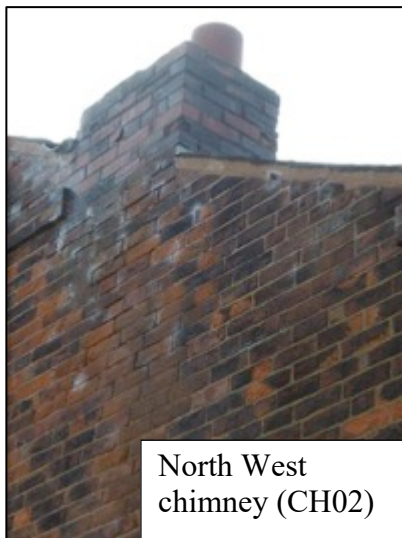
**Condition** – It was noted that some brickwork surfaces were starting to spall, and the condition of the head flaunching was deteriorating.

North West chimney (CH02)

**Action** – Undertake repairs to flaunching and pointing of brickwork to both chimneys. (Maybe consider rebuilding and increasing height?)      £

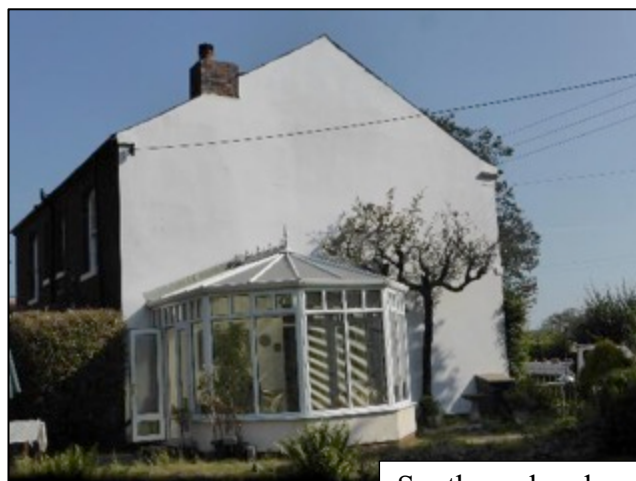
**Condition** – Paintwork was noted to be in a reasonable condition, but may require refreshing in the next two years. Redecoration of the rendered South elevation may be of benefit to address any potential hidden water penetration.

South rendered elevation

**Action** – Redecoration of all areas within three years £
- Total External Repairs** £
- 3.02 Internally House**
- 3.02.01 Roof Space** – Access is via a ceiling hatch located within FF07. There were no access boards for safe navigation. It was noted that the roof surface was under-felted.

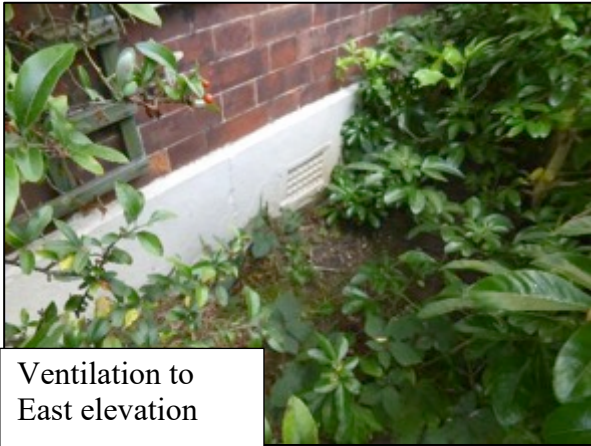
**Action** – None
- 3.01.11 Sub-floor ventilation** – Ventilation bricks were located to all the elevations, and were noted to be above eternal ground levels and free of debris.

Ventilation to  
East elevation

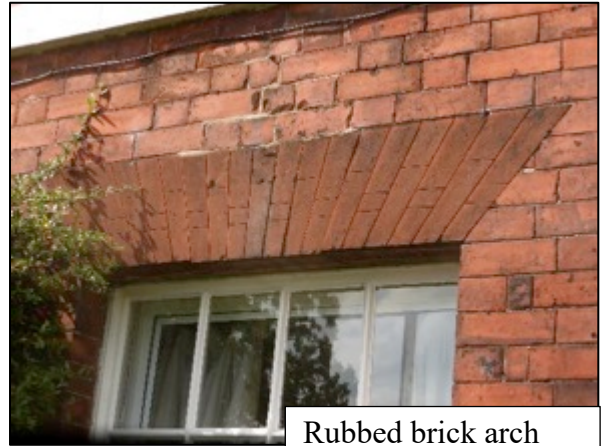
Rubbed brick arch  
above East window  
to GF02

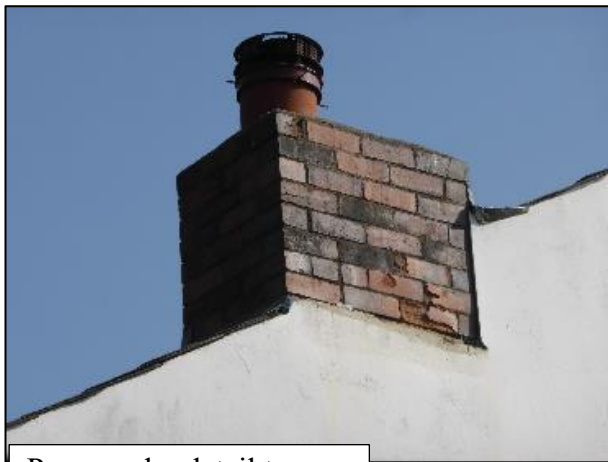
Poor render detail to  
South West chimney  
CH01

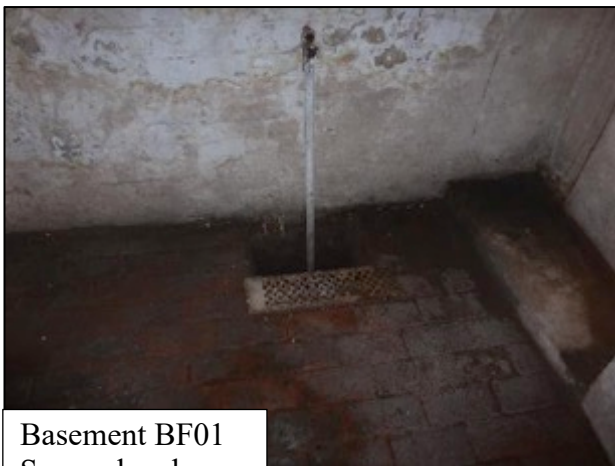
**Condition** – The area was sufficiently ventilated. It was noted that the timber window units were in need of refurbishment, and there was no evidence of a sump pump.

Basement BF01  
Sump chamber

**Action** – Modification or refurbishment of ventilation windows. £  
Installation or investigation of sump pump requirement. £
- 3.02.09 Doors** – Comprising timber framed and panelled units, set within timber frames.

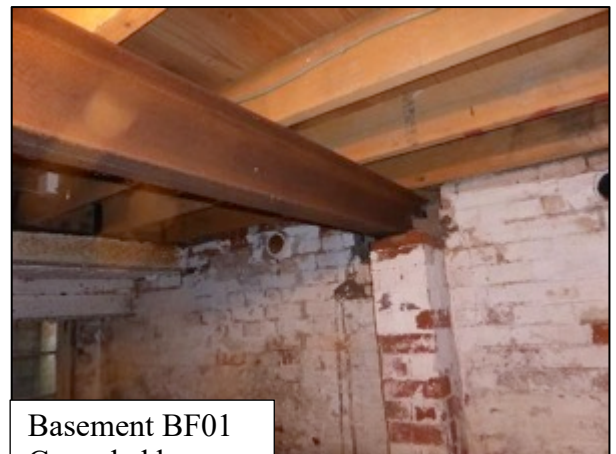
Significant corrosion (not structurally damaging) was noted to the steel beams within the basement, and they were also noted to be without any fire protection, which is now a requirement within the building regulations. Insulation was also not present to the timber floor above the basement (GF06), and an increase in the main loft insulation may be beneficial to the overall thermal performance of the building.

Basement BF01  
Corroded beam

**Condition** – No significant defects were noted to visible timber floor beams.  
**Action** – The steel beams with the basement are recommended to be prepared and treated with a rust inhibitive paint, or coated in an intumescent spray finish to provide sufficient fire protection for the upper floor structure.
